Golf Course Master Plan

August 2020

Basic Irrigation System Analysis

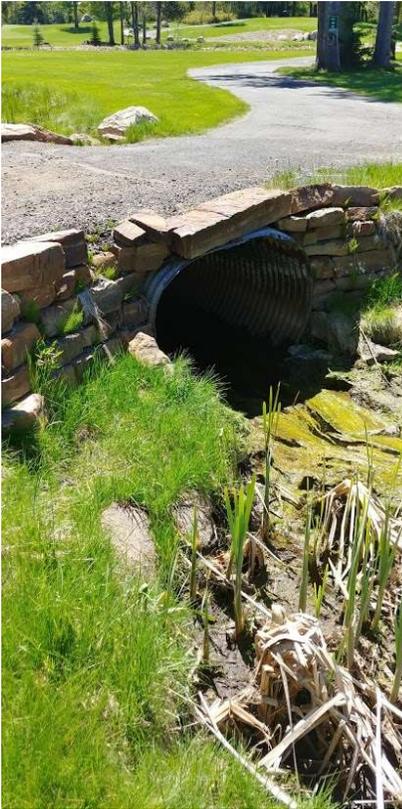
Existing cart path
Culvert Crossings
over Shiner Creek.

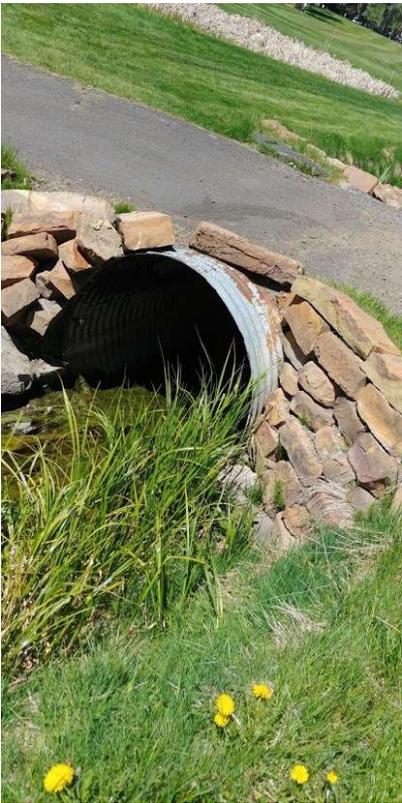
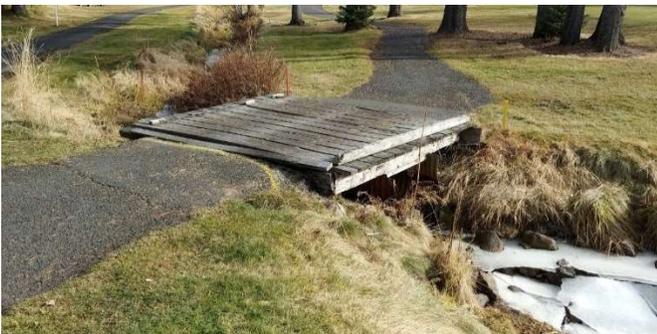
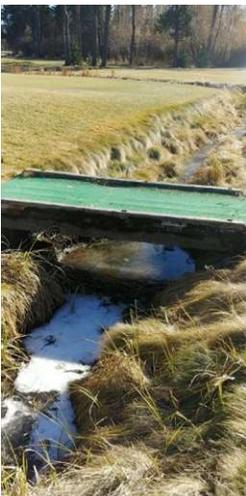
Cart and player
walking Timber
Bridges over
Shiner Creek with
deteriorating
planks and
possibly stringers.
Needs appropriate
safety curbing.
Path approach
should be
improved.

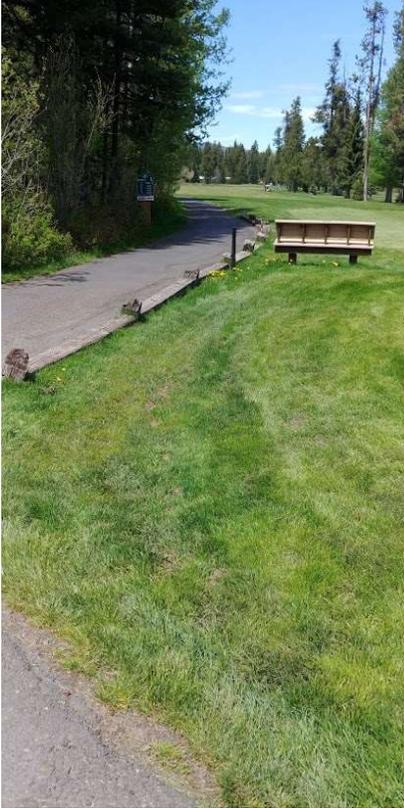
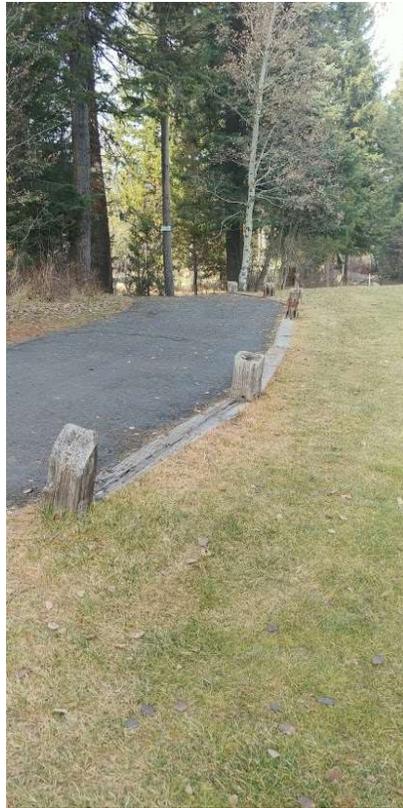
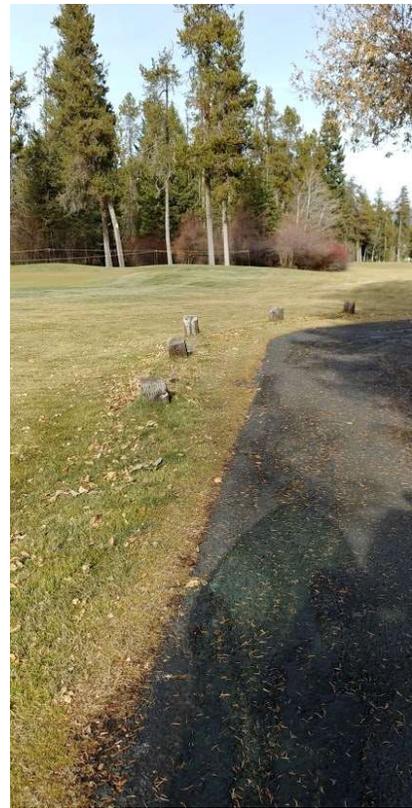
Curbing for traffic control was used sparingly in key areas along tees and greens in the form of RR ties and timbers. Much of this curbing is also deteriorating and will need to be replaced with something more appropriate when the paths are addressed.

Old and deteriorating Railroad Ties in use as traffic control curbing along asphalt paths. Result in awkward and inefficient maintenance requirements, poor aesthetics, and are potential trip hazards.

It is recommended that the existing paths be ground, excess material removed, and some be left in place as base material for a new asphalt layer. New paths must be finished flush to adjacent turf grades to ensure drainage run-off patterns are maintained or improved. 8' wide paths will serve both golf cart and maintenance vehicle purposes.

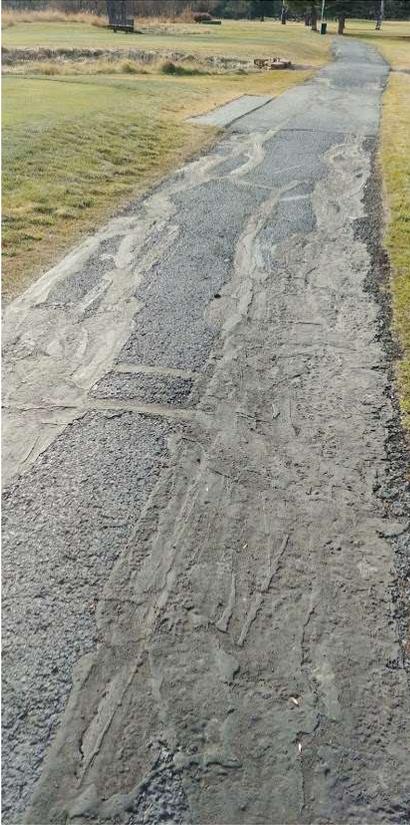
McCall Golf Club – Now 30 years old the asphalt paths throughout the course require attention and should be resurfaced. Occasional patching has helped prolong their condition for use, but that practice will no longer sustain usable paths. Their alignment is generally good, but all path locations should be assessed prior to any new path installation work. Clearing of snow and winter use of the paths has also added to the damage and deterioration of the asphalt paths over time.

Older deteriorating asphalt paving and paths.

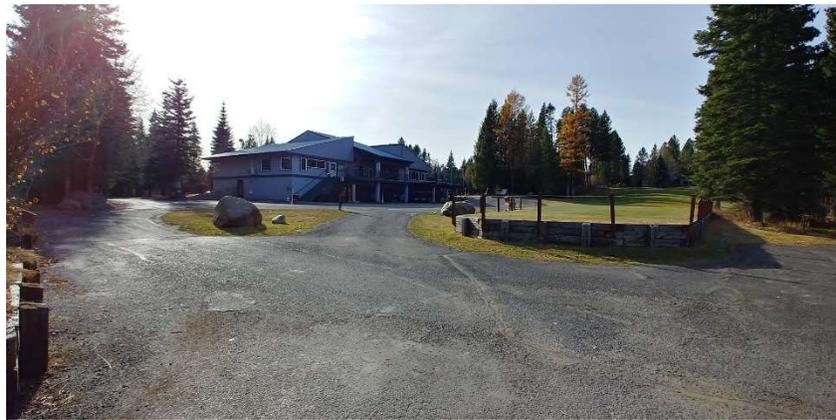
Cart path routed across line of play and in primary view. Ropes required due to poorly draining area beyond path.

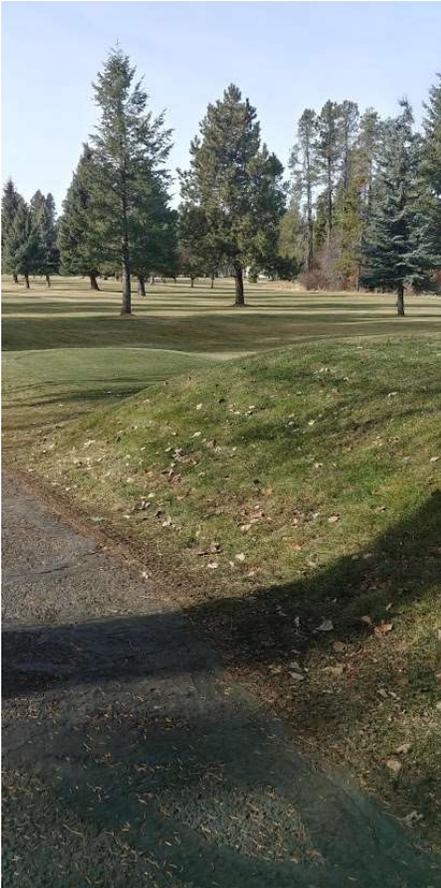
Excessively steep tee banks.
Difficult for golfers and mowers to traverse.

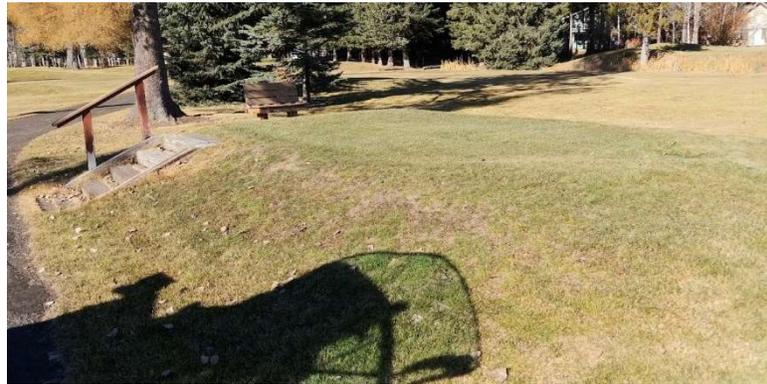
Unnecessary and deteriorating railroad tie bulkhead wall creating inefficient mowing requirements and awkward access for golfers.

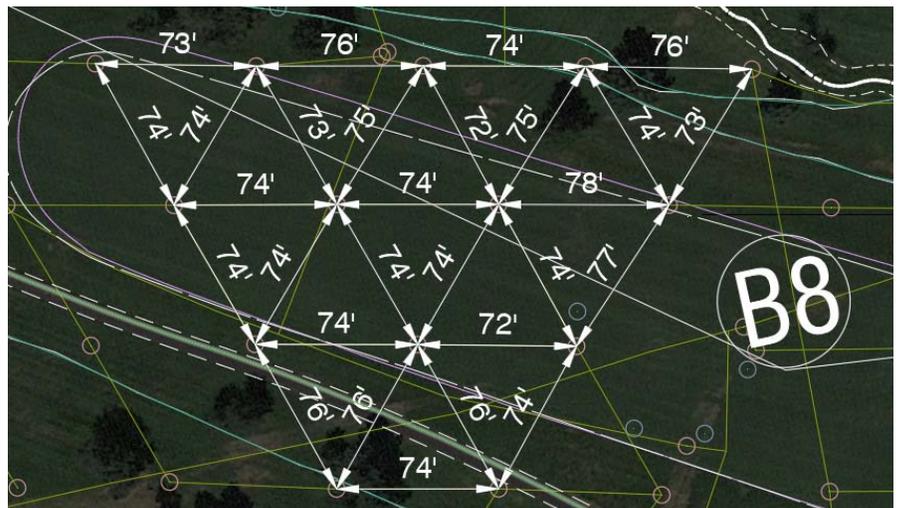
Sprinkler Spacing on Birch hole 8

The current sprinkler layout on Aspen and Birch has remained unchanged from the original installation in 1998. Sprinkler spacing on Aspen and Birch is fairly consistent between 72' to 78' equilateral triangulated spacing through the fairways and roughs. Aspen and Birch primarily have single head control and it appears that staff is able to uniformly irrigate the playable areas of the golf course. In evaluating turf quality on Aspen and Birch while on site and via google earth we noticed that turf conditions are fairly uniform and appear to be in good health, as witnessed in the image to the right.

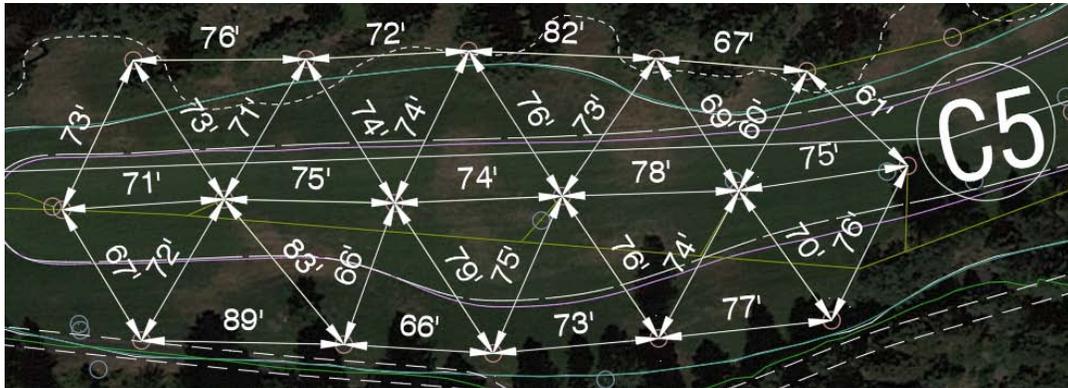
Sprinkler Spacing on Cedar hole 5

The original irrigation system on Cedar was installed on a budget, value engineered and generally consisted of a single row of sprinklers down the fairways spaced between 71' to 78' with multiple sprinklers surrounding the greens and tees. The course staff quickly realized that single row coverage was inadequate. To remediate the issue, staff renozzled the original sprinklers to throw further out to the edge of fairway and started adding sprinklers to the edges of the fairways in order to increase playable turf areas. The newly added sprinkler spacing ranges significantly between 67'- 89'. Today, there are sections of fairways with three sprinklers crossing the fairway and in other locations the single row still exists. Additionally, homes are being constructed adjacent to each golf

hole requiring further modification to the irrigation system to prevent irrigation overspray onto adjacent properties. In the image below titled "sprinkler Spacing on Cedar hole 5" you can see the wet and dry areas through the fairway.

Groups of up to four sprinklers are paired together on a block zone making it impossible to properly manage irrigation application between single coverage areas, double coverage areas and the various microclimates, topsoils and slopes on the golf course. It is obvious that poor and inconsistent coverage and lack of control makes it impossible to manage the irrigation system and provide uniform playing conditions on Cedar.

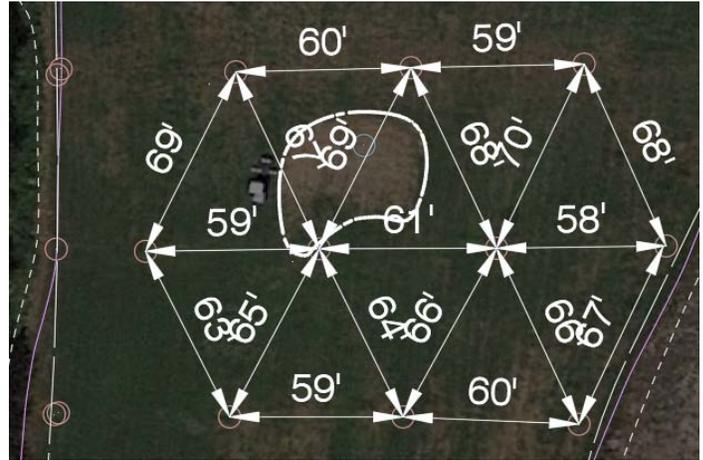
The driving range is unique to the rest of the golf course. Approximately 2/3rd of the range is irrigated while the remaining 1/3rd had an irrigation system but was abandoned 15 years ago. The portion that is irrigated was constructed with typical landscape rotors you might find on residential or light commercial projects. They are not engineered to withstand the climate or pressure demands on a golf course. The sprinkler spacing varies between 60'-70'. Coverage is poor and is apparent in aerial photographs.
