Golf Course Master Plan

August 2020

Basic Irrigation System Analysis

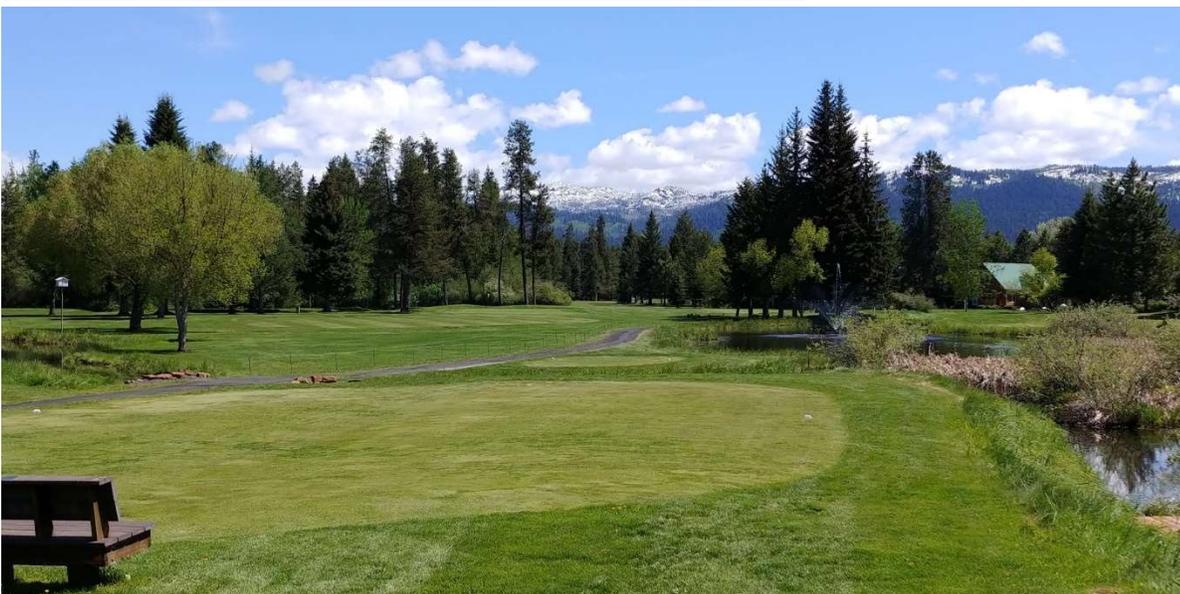
Cart path routed across line of play and in primary view. Ropes required due to poorly draining area beyond path.

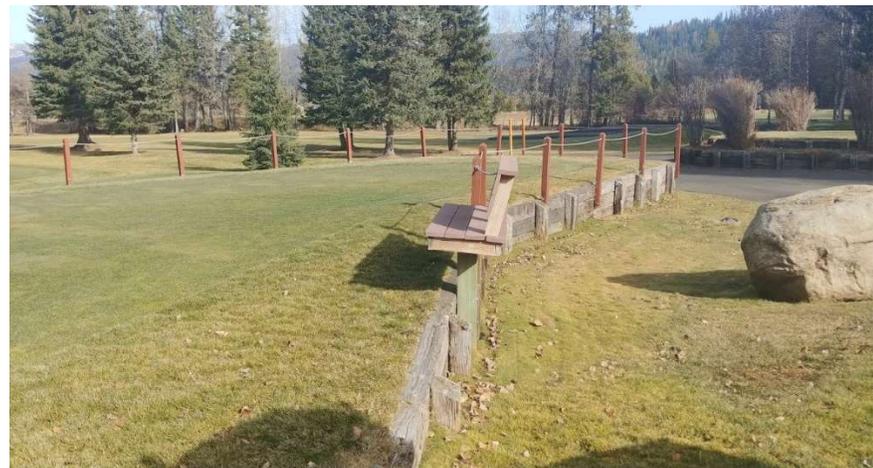
Unnecessary and deteriorating railroad tie bulkhead wall creating inefficient mowing requirements and awkward access for golfers.

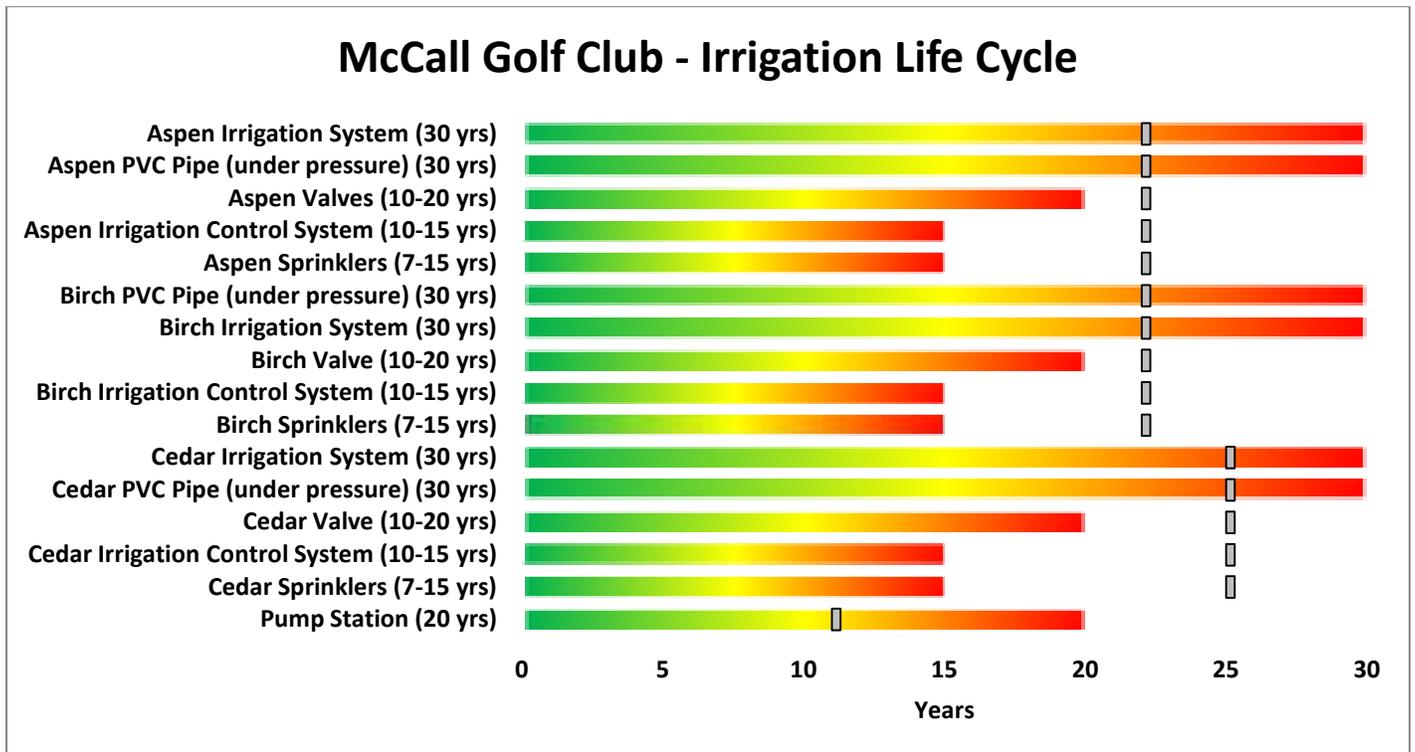
The life cycle bar for each component group listed below is represented with green, yellow and red. Green represents components that are respectively new with no maintenance required. Yellow represents the period in which products should still function however minimal maintenance may begin to occur. Yellow is also a time period in which budget planning for future replacement of the components or system should be considered. Red represents components that are near or at the end of their expected life cycle and components or system failures begin to increase. Each grey bar represents the respective component age of each category. This is a very high level observation tool to gauge where a system is overall within the average life cycle however, many variables including design, installation, water quality, maintenance and climate may shorten or extend the life of an irrigation system. Using this general observation, many of irrigation components on the golf course have exceeded their expected life cycle.
